Manhole Inspection Summary

Manhole # S55E__028MH

Insp Date: **7/22/08 11:12 AM**

Location Address: **side 3424 e pratt st**

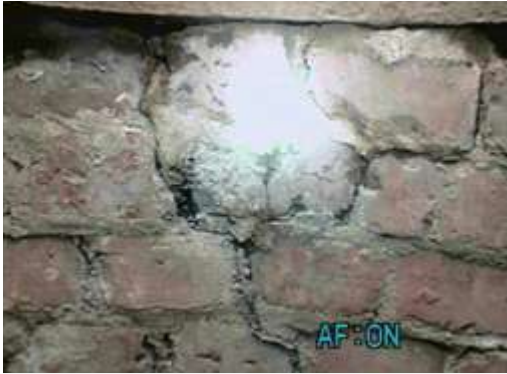
Defect 2

Condition: ☐ Sound ☒ **Cracked** ☐ Root Intrusion ☐ Loose Brick ☐ Deteriorated

cracked corbal

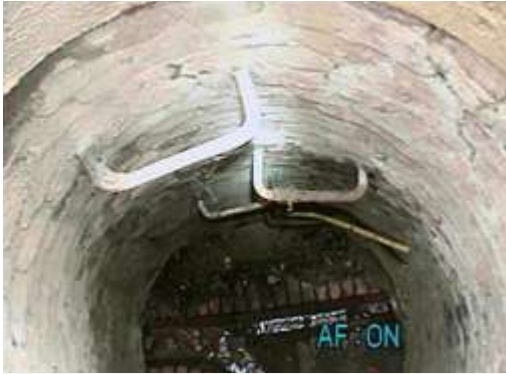
Defect 1

Condition: ☐ Sound ☒ **Cracked** ☐ Root Intrusion ☐ Loose Brick ☐ Deteriorated

cracked, frame adj

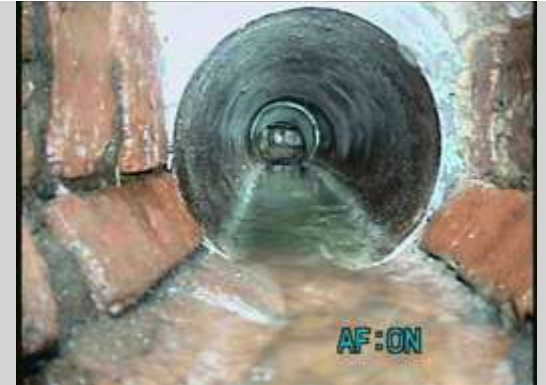
12 O'Clock Outflow

8 in. Circular Gravity Sewer
Pipe Out @ 12 O'Clock

Invert Depth: **9.08** (ft.) Flow Characteristics: **Slow**

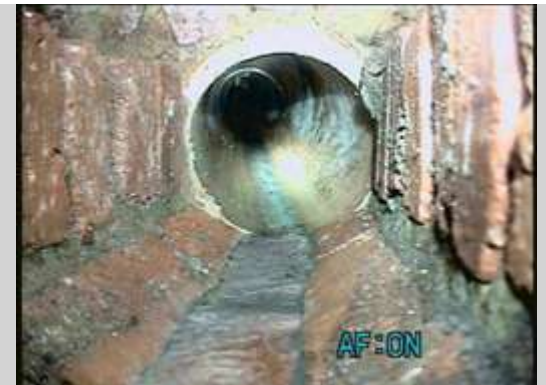
6 O'Clock Inflow

6 in. Circular Gravity Sewer
Pipe In @ 6 O'Clock

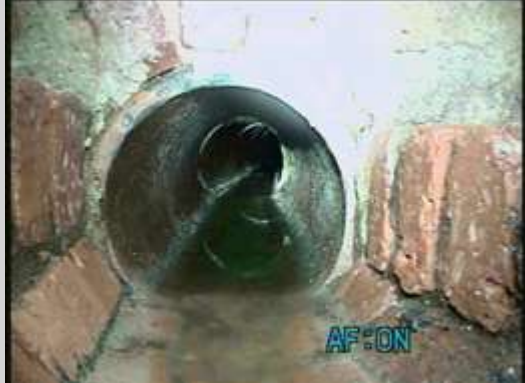
9 O'Clock Inflow

8 in. Circular Gravity Sewer

Pipe In @ 9 O'Clock
